<u>Technical details on revegetation/reforestation methods in the</u> <u>"Amiantos" asbestos mine at Troodos, Cyprus</u>

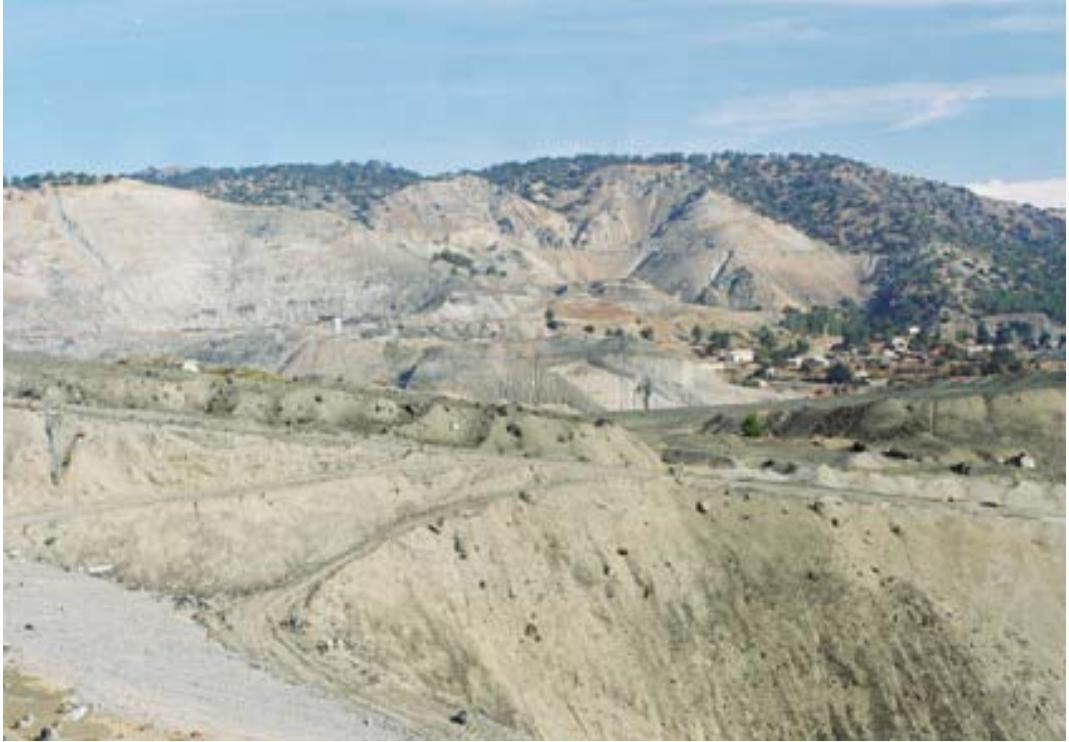
A general view of the mine prior restoration works

• The surface of the mine is occupied by asbestos wastes and rock fronts, which are potential sources of air born asbestos fibers, and therefore they should be covered by some means, to reduce fibers released in the air.

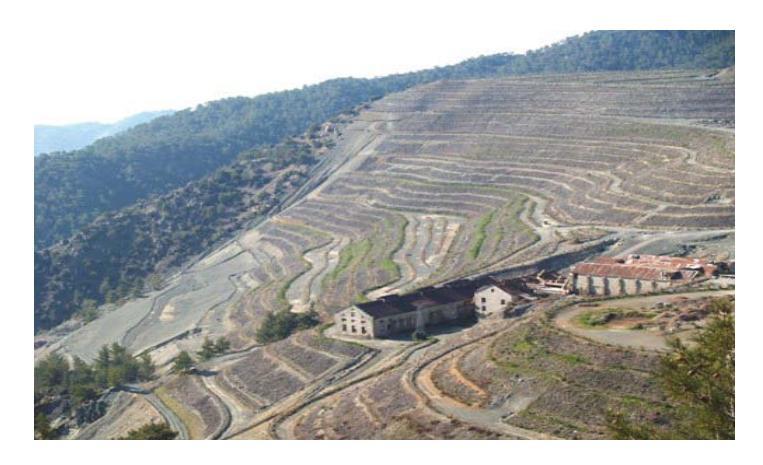
A picture showing terraces after reshaping and restoration

After discussions, the maximum acceptable angle of the slope in steep slopes was specified at 27°, which corresponds to an inclination of 51 percent (2 horizontal: 1 vertical). The minimum width of terraces agreed was 8 m to allow movement of trucks that would transport soil and other material.

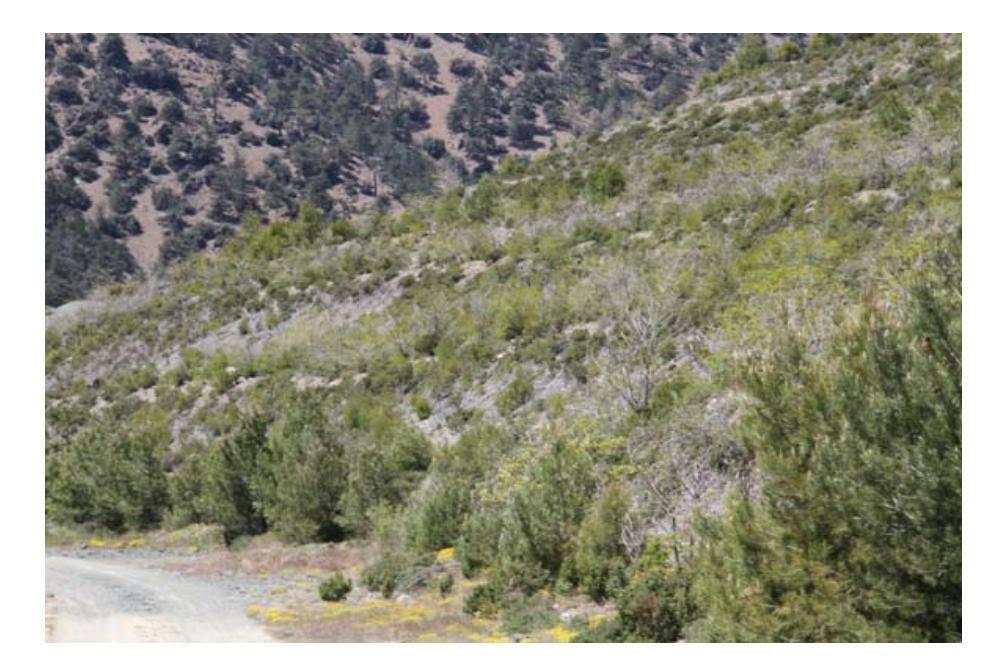
A closer view of restored slopes

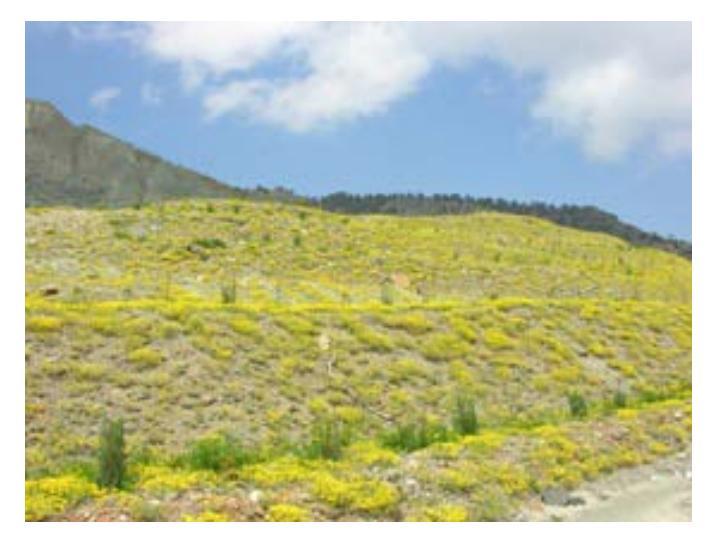
Results of hydroseeding (the yellow colored flowers belong to <u>Alyssum cypricum</u> a near- endemic serpentinophilous perennial species)

Finally, "hydro-seeding" a restoration technique successfully applied in many countries in mine restoration works, has been introduced in 2003, and though cheaper than thatching, it is not as effective, perhaps because of erroneous application. Improvement of hydroseeding application in the mine is a must and it may contribute to significantly reducing re-vegetation costs and to increasing the area restored annually.
